SealBoss Case Study

Location: Texas State Aquarium, Corpus Christi Texas

Scope: Water intrusion around large Salt-Water Tanks, where salt deposits visibly indicated water presence.

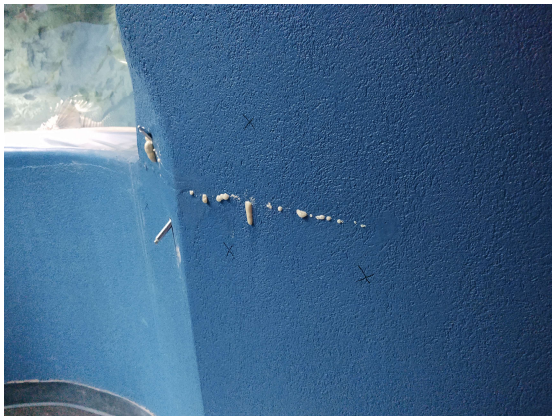
Material travel along the wall.

Allowing the material to set up and begin to cure (70 seconds based on 10% accelerator) observation of material travel from the injection point and exit the wall 4-6 inches away, indicating the capillary was filled successfully.

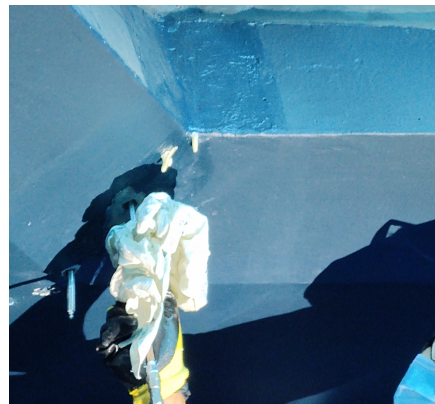
Cold Joint Injection.

Injection into a cold joint used a different technique. Drilling and placement of packers directly onto the cold joint to quickly seal a presence leak. Proper water displacement and material travel up and along the cold joint indicated it was sealed properly and prevented further water intrusion.
